By **Bill Parsons** Vice Chairman, Seven Oaks CDD

One of the favorite attractions at the clubhouse is the slide for the Junior-Olympic Lap Pool. That is why it was an easy decision a couple of months ago for the CDD Board to allocate funds to make major repairs to the slide. The CDD Board had made periodic repairs since it was built in 2002. These included blasting/repainting/re-gelling at a cost of \$60,611 in 2006 and the interior of the slide being re-gelled twice and joints sealed since 2006 costing \$27,500.

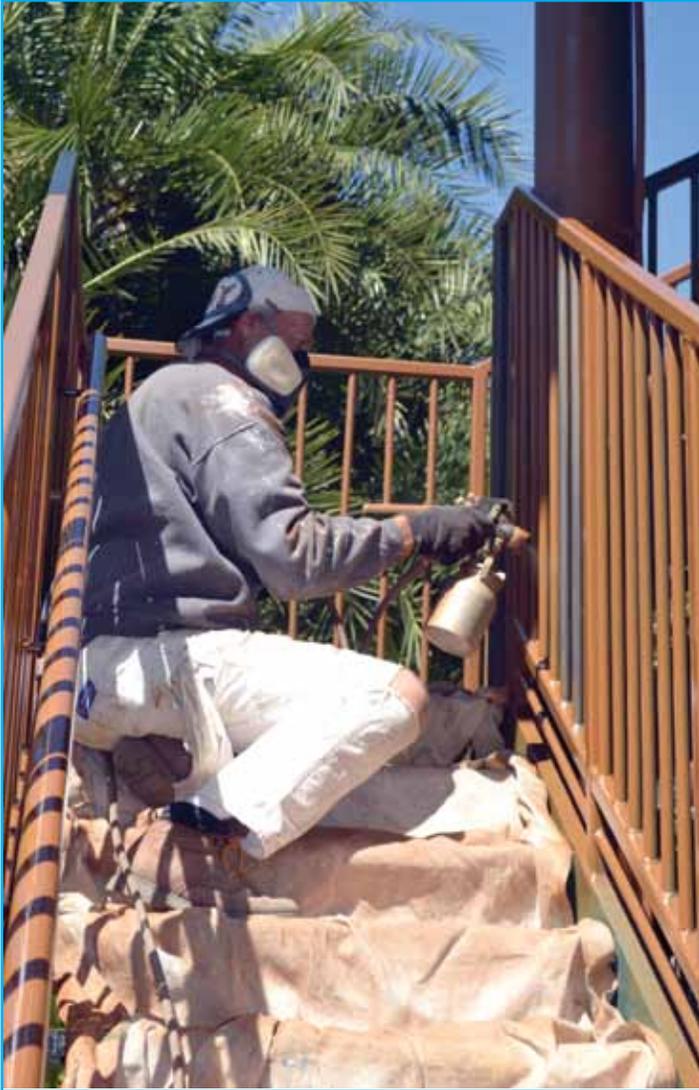
Steve Swartz, Kalos Coatings employee, sprays primer on the railing going to the top of the slide. Prior to putting on the primer, all rust was removed and any bad areas repaired.

To insure the finish on the structure of the slide would last for many years, the contractor gave all new and existing steel a brush-off blast to remove oil/grease/dirt/dust/loose rust. Then, they applied a sealer. Next, they sprayed a spot primer on rusted areas/bare areas/welds/seams. This was followed by a full coat primer for the entire structure. Finally, two coats of PSX700 Polysicloxane, a coating that is used on the Golden Gate Bridge and decks of aircraft carriers, was applied.

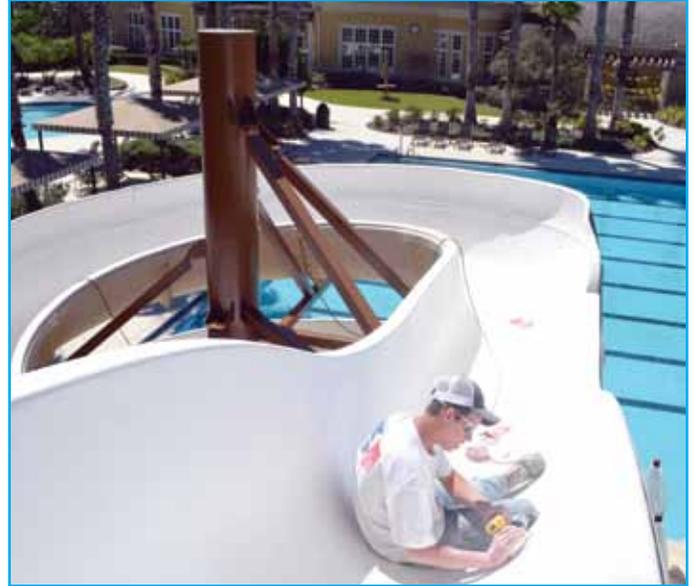
Derrick Bolding, Kalos Coatings employee, sanding the inside of the slide to make it smooth. It will also provide a faster ride.

To improve the surface portion of the slide where people slide down, the contractor used a 4-step process of different grit sandpaper for each step to achieve a very smooth finish. This was followed by a 21-step process to meet SlideRenu's specifications for the inside and outside of the slide.

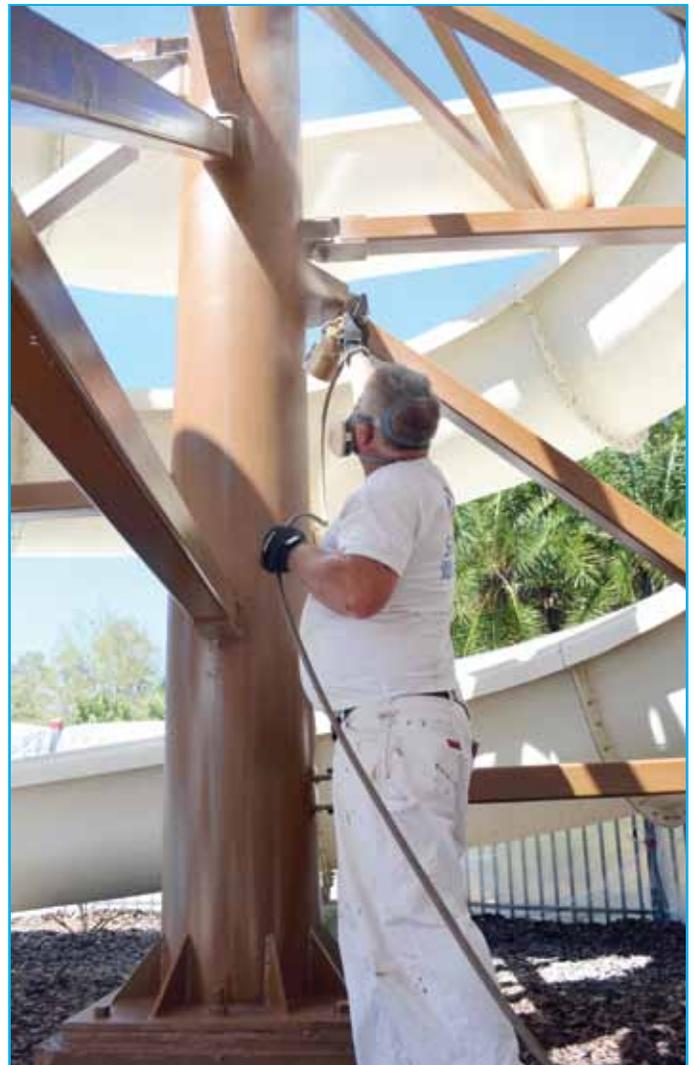
Charlie Daniels, supervisor for Kalos Coatings, sprays the inside structure of the slide with primer.

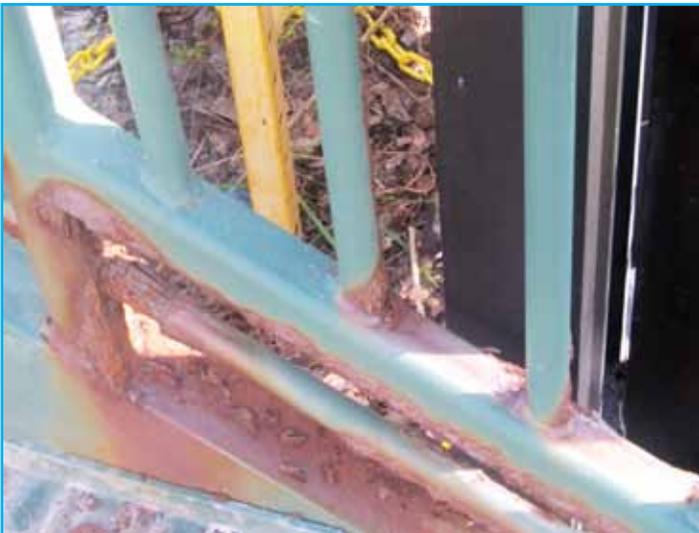
According to Dave Metrey, President of Kalos Coatings, several things needed to be changed from the way the slide had been originally constructed. One was the knife plate connections that connect to the steel tubes that make up the structure. They only had two bolts which allowed water to get inside and rust the

This is an example of how some of the railing rusted from the inside out and had to be replaced before it could be painted.

construction from the inside out. Twelve metal handrail sections about three feet long had to be cut out and replaced with custom fabricated new handrails to match the existing ones.

To remedy the rust problem, the contractor used three bolts with a very precise fit. This will prevent water from getting on the inside of the hand railings. Another issue was that stainless steel bolts were used when the slide was built. The contractor replaced all of these bolts with structural bolts that are much stronger.
